ACT
Government

UTILITIES TECHNICAL REGULATION ANNUAL COMPLIANCE REPORT 2017-18

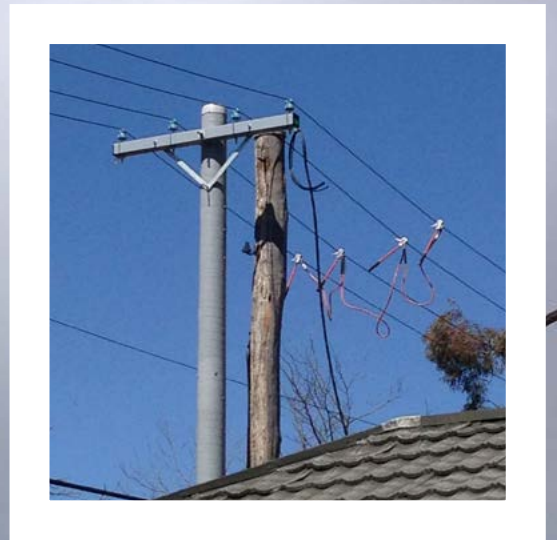
MAIN: EVOENERGY POWERPOLE IN URBAN AREA, ABOVE: EVOENERGY POLE REPLACEMENT PROGRAM

A key risk factor to Evoenergy's operations and the community is the structural integrity of their power poles. To control this risk Evoenergy has a rolling condition testing program for power poles. The purpose of the program is to confirm that poles in their network remain safe (structurally adequate). 'Condemned' poles are deteriorated poles that represent an increased risk to public safety and supply continuity. Evoenergy procedures require that condemned poles are replaced or remediated within 12 months for distribution poles and 24 months for transmission line poles. This procedure is based on the assessment by Evoenergy that, if left for a longer period, the risk to the community from a falling pole becomes unacceptable.

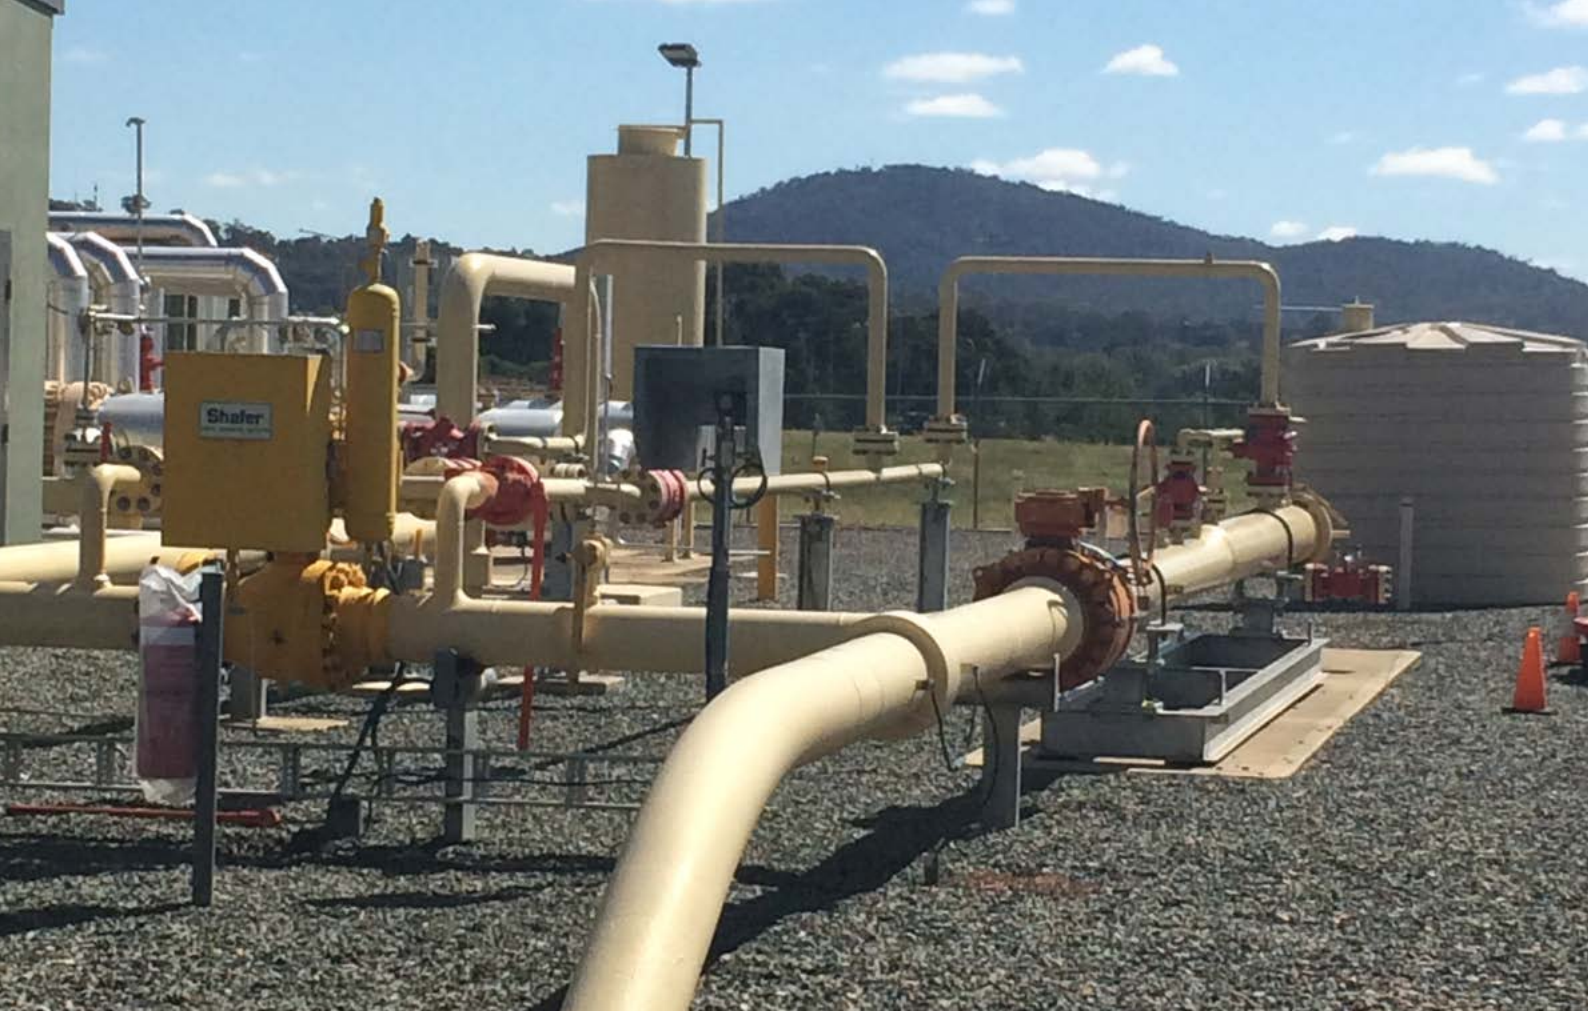
FYSHWICK NATURAL GAS TRUNK REGULATOR STATION

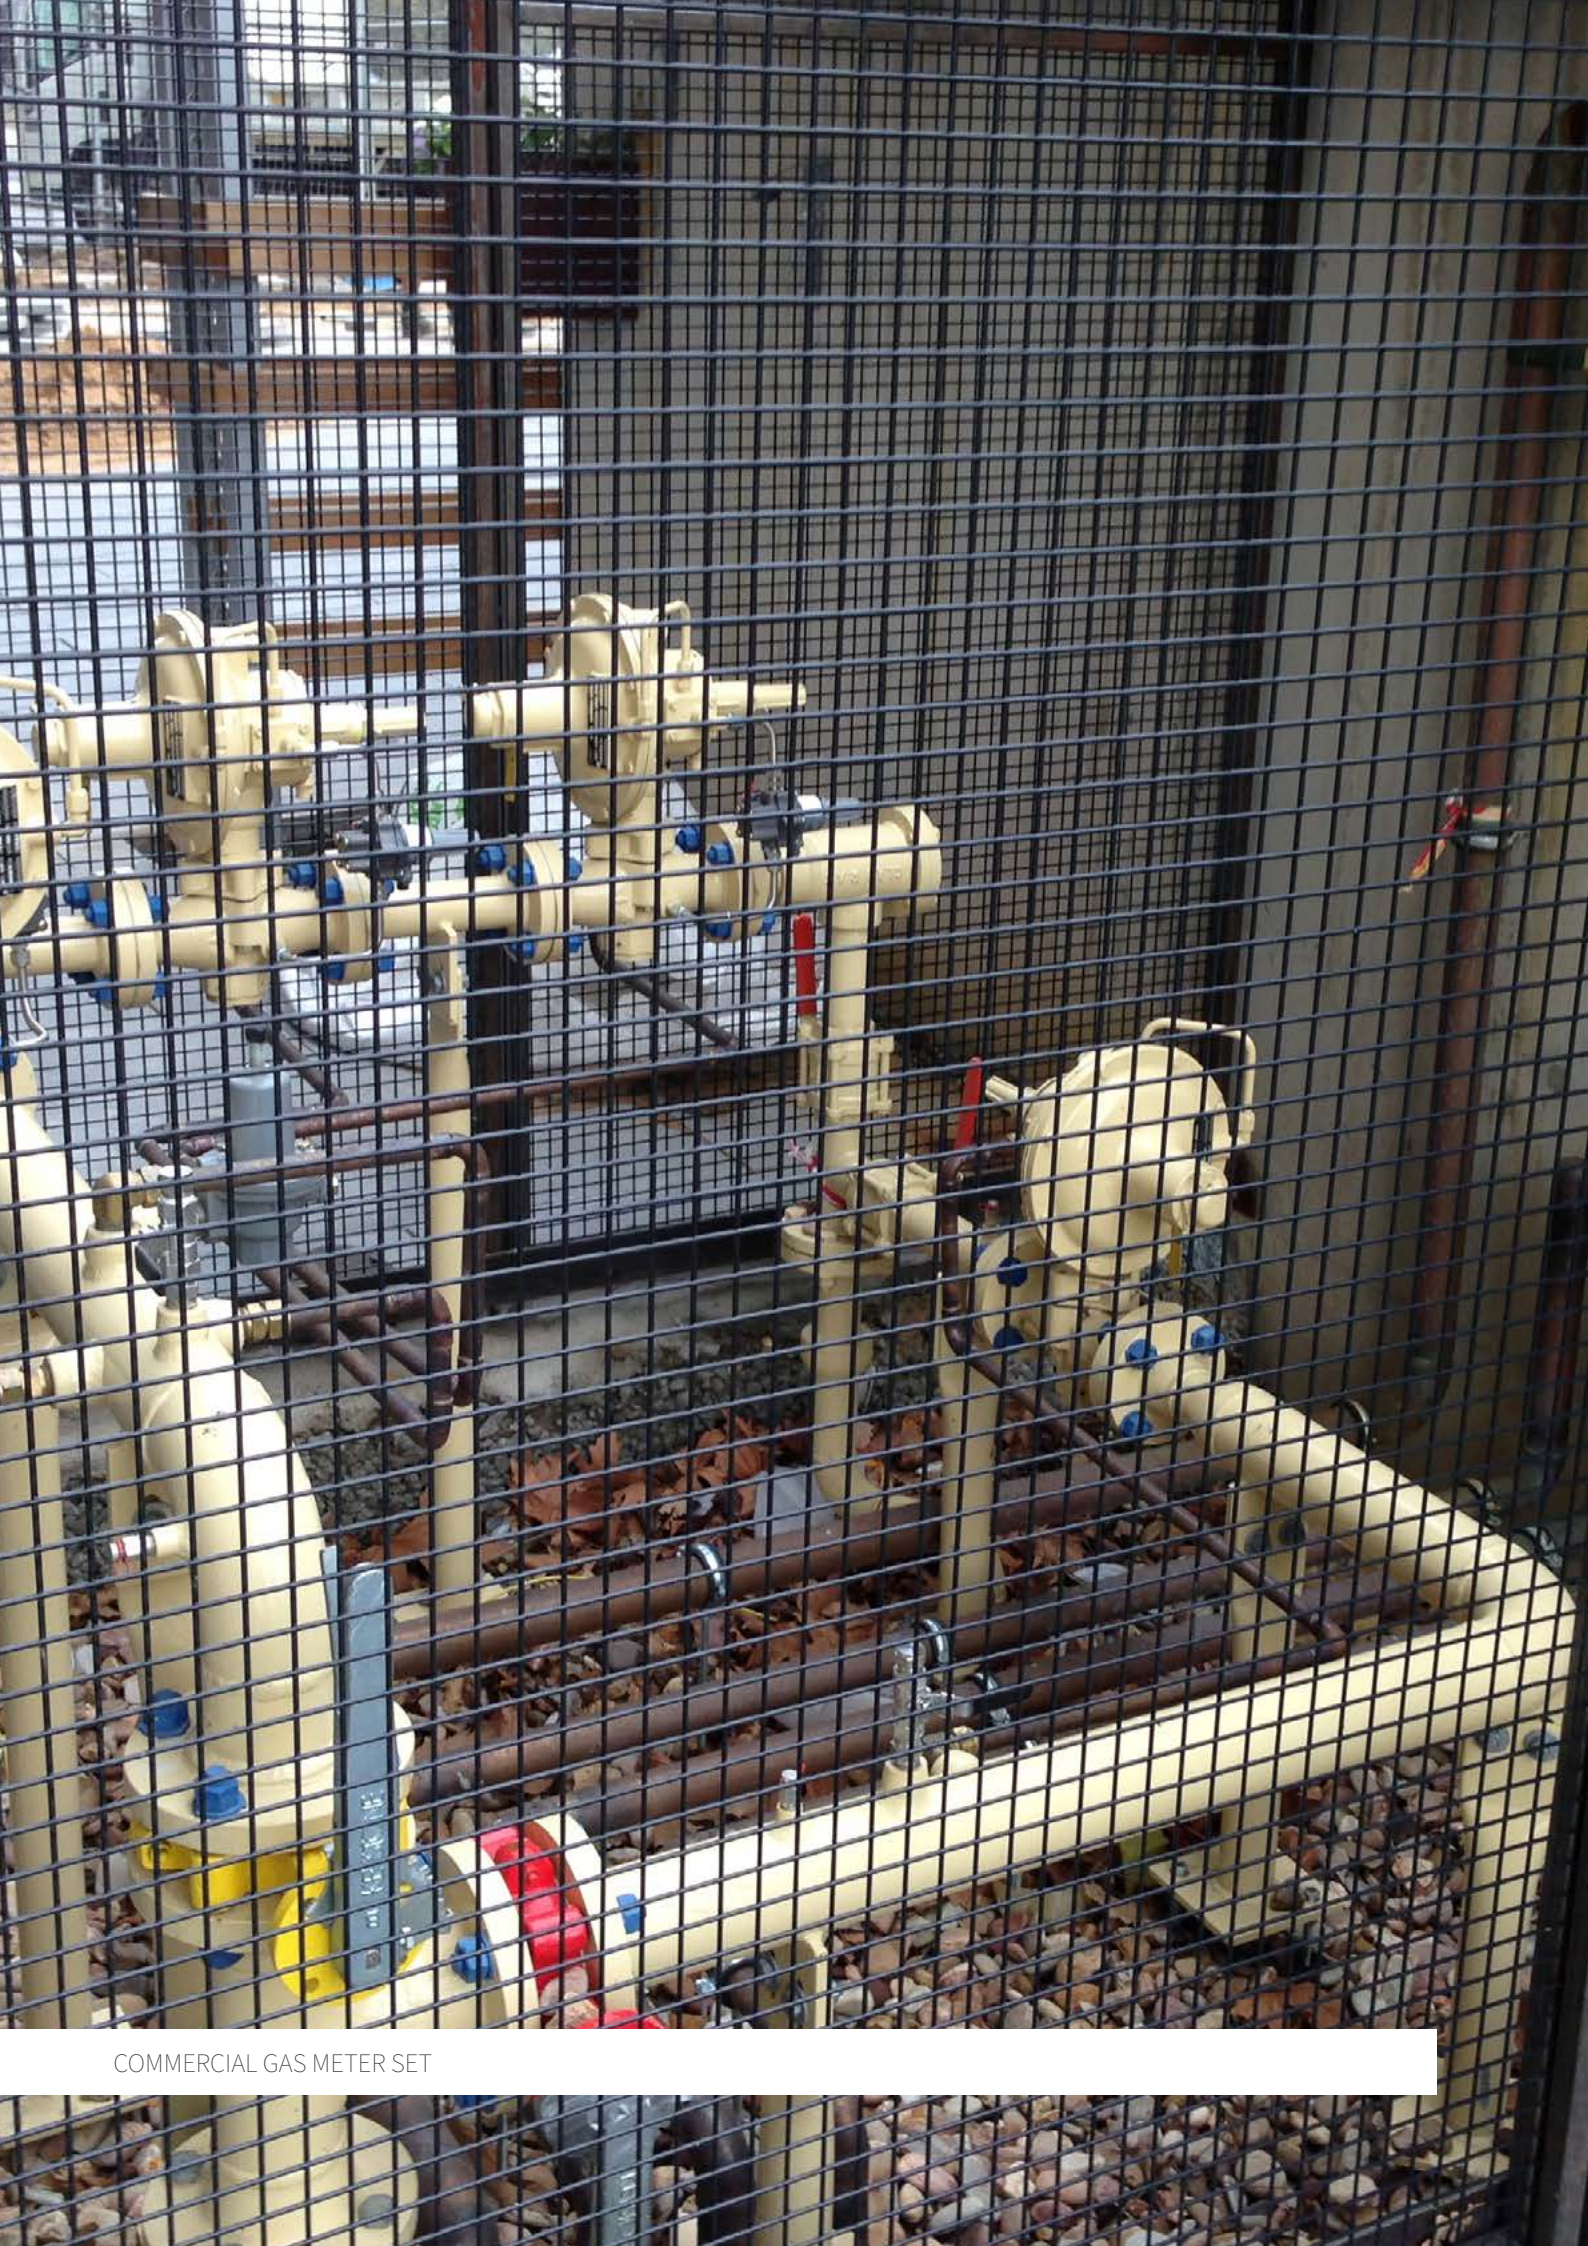
COMMERCIAL GAS METER SET

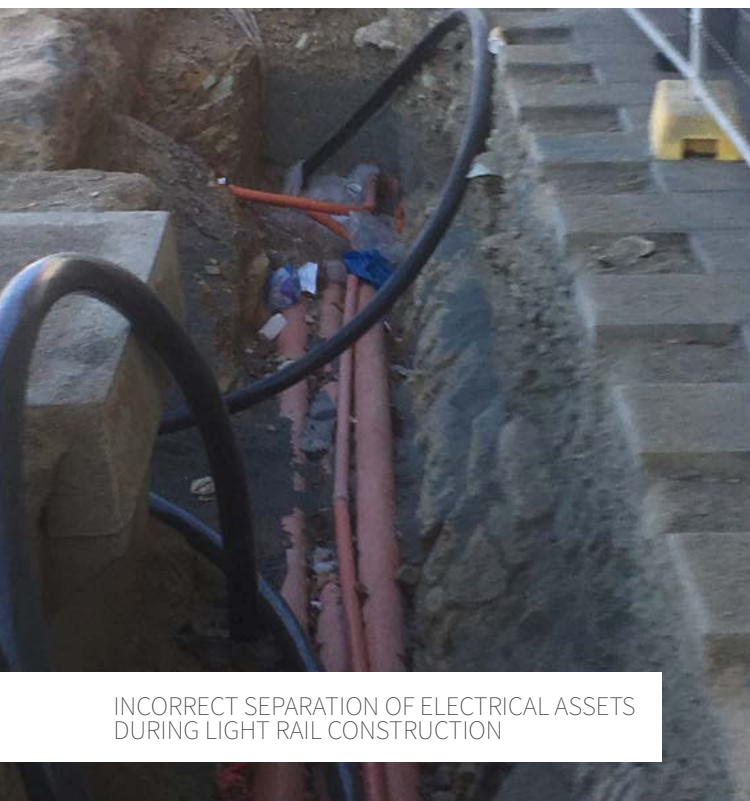
INCORRECT SEPARATION OF ELECTRICAL ASSETS
DURING LIGHT RAIL CONSTRUCTION

UTR held a number of concerns during the 2017–18 reporting period in relation to the installation of electrical cabling. The project experienced a number of LV electrical cable strikes, and there were incidents involving damage to other utilities such as the streetlight and gas networks. UTR continues to investigate electrical safety performance. Considerations regarding the adequacy of Safety Management Systems for the project remain ongoing.
